Indian Ocean Earthquake- Tsunami of 26 December 2004

UNDAC Rapid Environmental Assessment Republic of Maldives

January 2005

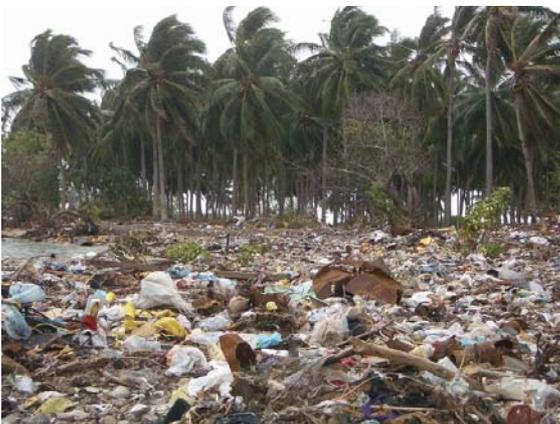
The tsunami destroyed an enormous amount of houses on numerous islands. At the time of writing the Government of the Maldives had registered 3997 houses that had been damaged. The amount of construction/demolition waste consists from individual cement bricks to complete intact walls that have collapsed. On some of the worst affected islands, such as Vilifushi on Thaa Atoll, all the houses have been completely destroyed.

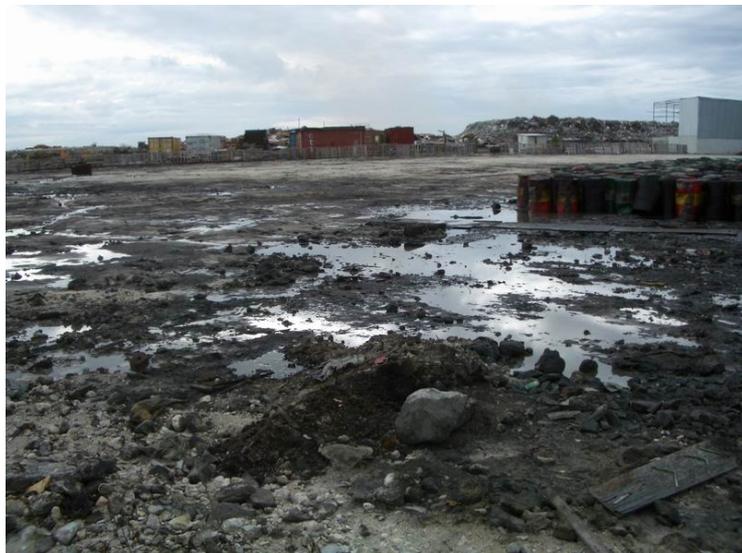
Thilafushi is an island close to Male and consists of three main parts; storage houses, light industries and the main waste dump site of the Maldives. On the part of the island where the waste is being dumped approximately 300 drums of 205 liters containing used oils are being stored next to the water. No containment walls or foundation against leakage are in place.

Poor storage facility and waste oil spill threaten the marine environment

The waste oil is collected and used as fuel to burn the waste that is being dumped and burnt in open air. The drums are in very poor condition: rusted and some of them are open. An area of approximately 200 m² has been polluted with a layer of waste oil. At the moment of the site visit, oil was still flowing into the

sea. To the responsible staff present, the urgent recommendation was made to immediately build a small dam to prevent further seawater contamination. A further clean up and proper treatment of the polluted soil is required.

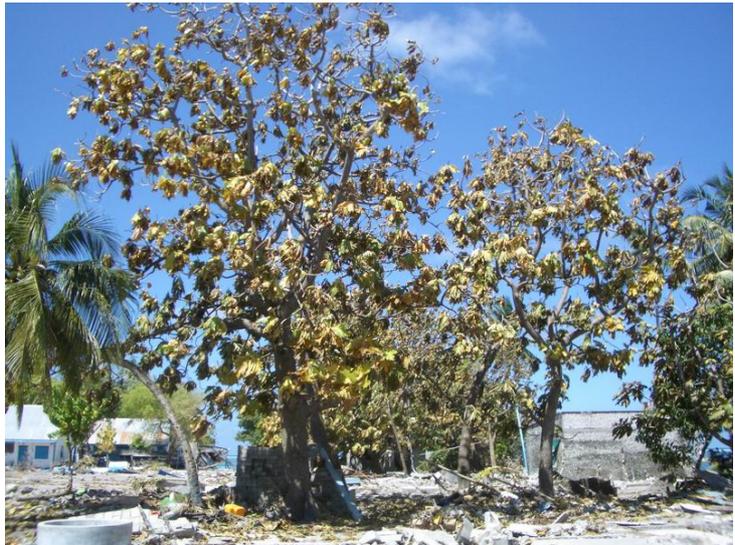
The main impact of the tsunami on the biodiversity of the Maldives is through the intrusion of seawater in the fresh water aquifers on the almost 1,200 islands. The immediate impacts were visible within two days after the disaster on the vegetation. Agricultural land, back yard farming, wetlands, as well as mangrove and other coastal vegetation have all been affected. Medicinal plants, that play an important role in the life of the island population, have also been severely impacted.

Dieback of vegetation occurred within days after the tsunami

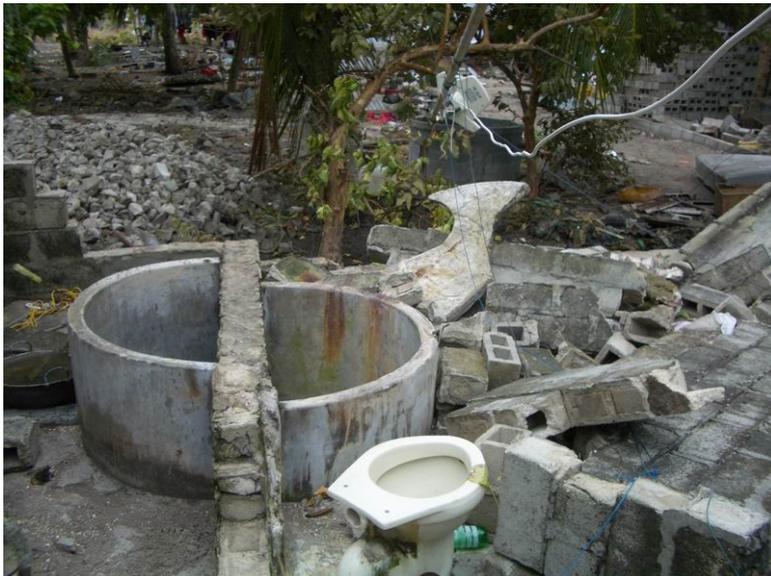
The use of open wells contributed to the intrusion of salt water into the fresh water lens

Islands contain small water lenses not too deep from the surface. Households have open wells in their house and use the groundwater for washing and laundry purposes (see photo). Rainwater is being harvested from roofs and stored for drinking water. Only in prolonged dry periods (dry monsoon) some islands have to use the groundwater for drinking purposes.
